Manhole Inspection Summary

Manhole # S350__005MH

Insp Date: **7/27/09 4:53 PM**

Location Address: **122 WARREN ST.**

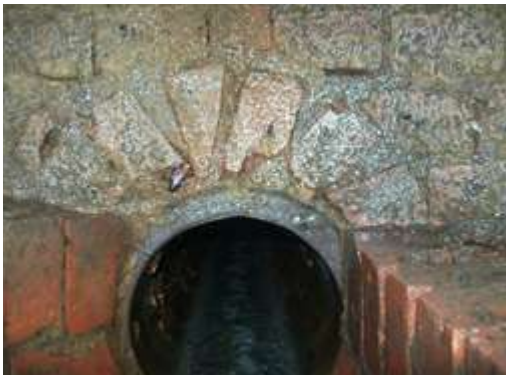
Defect 2

Infiltration: ☐ None ☐ Joint ☐ Cracks ☐ Mortar ☐ Roots ☒ **Wall**

seepage infiltration at barrel wall

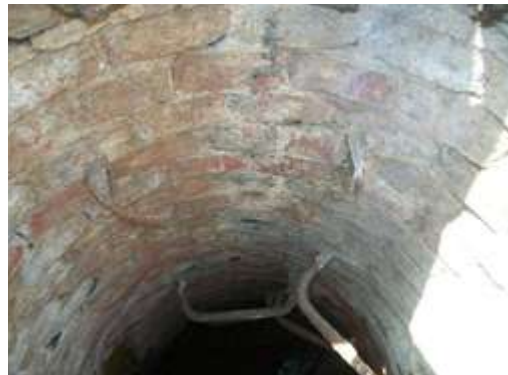
Defect 3

Steps Count: **6** Missing: **1** ☒ **Corroded**

missing/corroded steps

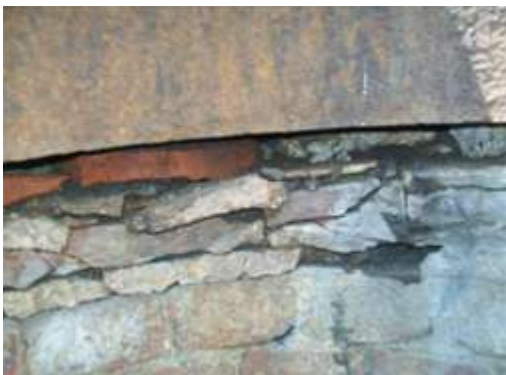
Defect 1

Condition: ☐ Sound ☐ Cracked ☐ Root Intrusion ☒ **Loose Brick** ☐ Deteriorated

CHIMNEY: BROKEN/ LOOSE BRICKS

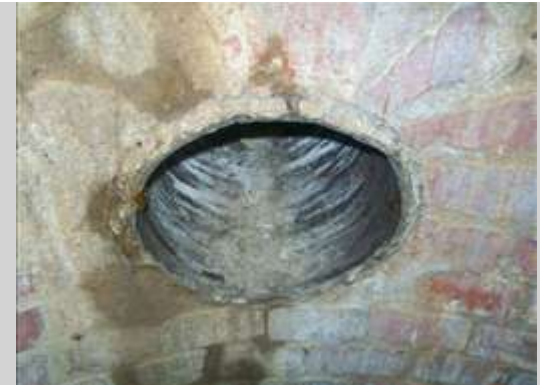
9 O'Clock Inflow

connection is abandoned

Connects To: **Stub connection / abandoned**

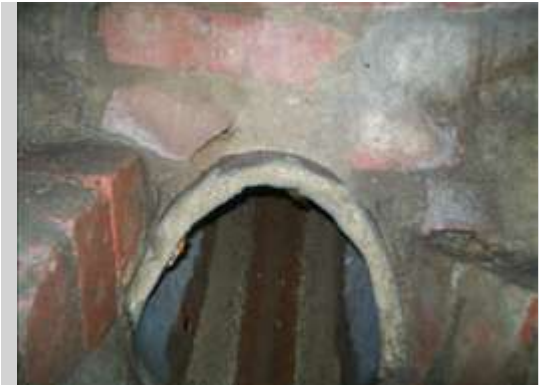
Drop In @ 9 O'Clock

connection is abandoned

Drop: **Outside** Rod and Bar
